DVE 8031/8032
TECHNICAL SERVICE BULLETIN #1

Product: DVE 8031 / 8032

Date: March 4, 2002

Re: Installation of G15381- Conversion Kit DVE 803x

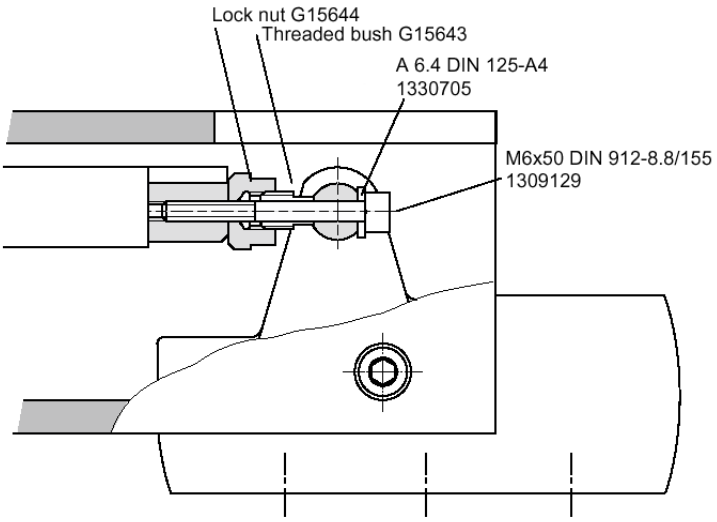
Diagram for reference only

Reason/Rational: Draeger Medical has released a hardware modification to increase the vertical stability of the pendant head or pendant column.

Devices affected: Ceiling Supply Units DVE 8031/ 8032 up to serial number ARND-0235 (prior to May 1999), **without** combination of adjusting nut G15644 and threaded bushing / nut assembly G15643.

Solution/Procedure: Install part number G15381- "Conversion Kit DVE 803x". Refer to Service Procedure SP00239. See "Additional Info", below.
